Living with the West Florida shore

Larry J. Doyle, Dinesh C. Sharma, Albert C. Hine,
Orrin H. Pilkey, Jr., William J. Neal, Orrin H. Pilkey, Sr.,
David Martin, and Daniel F. Belknap

Duke University Press Durham, North Carolina 1984
Property of CSC Library

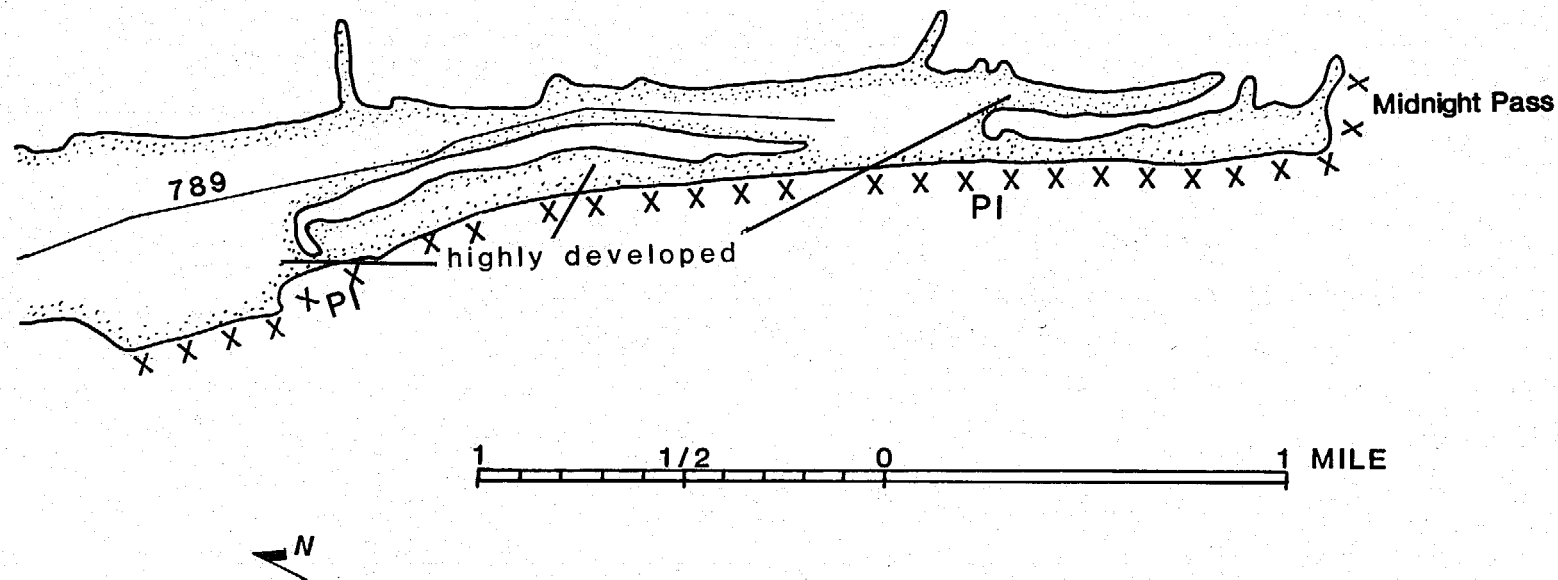
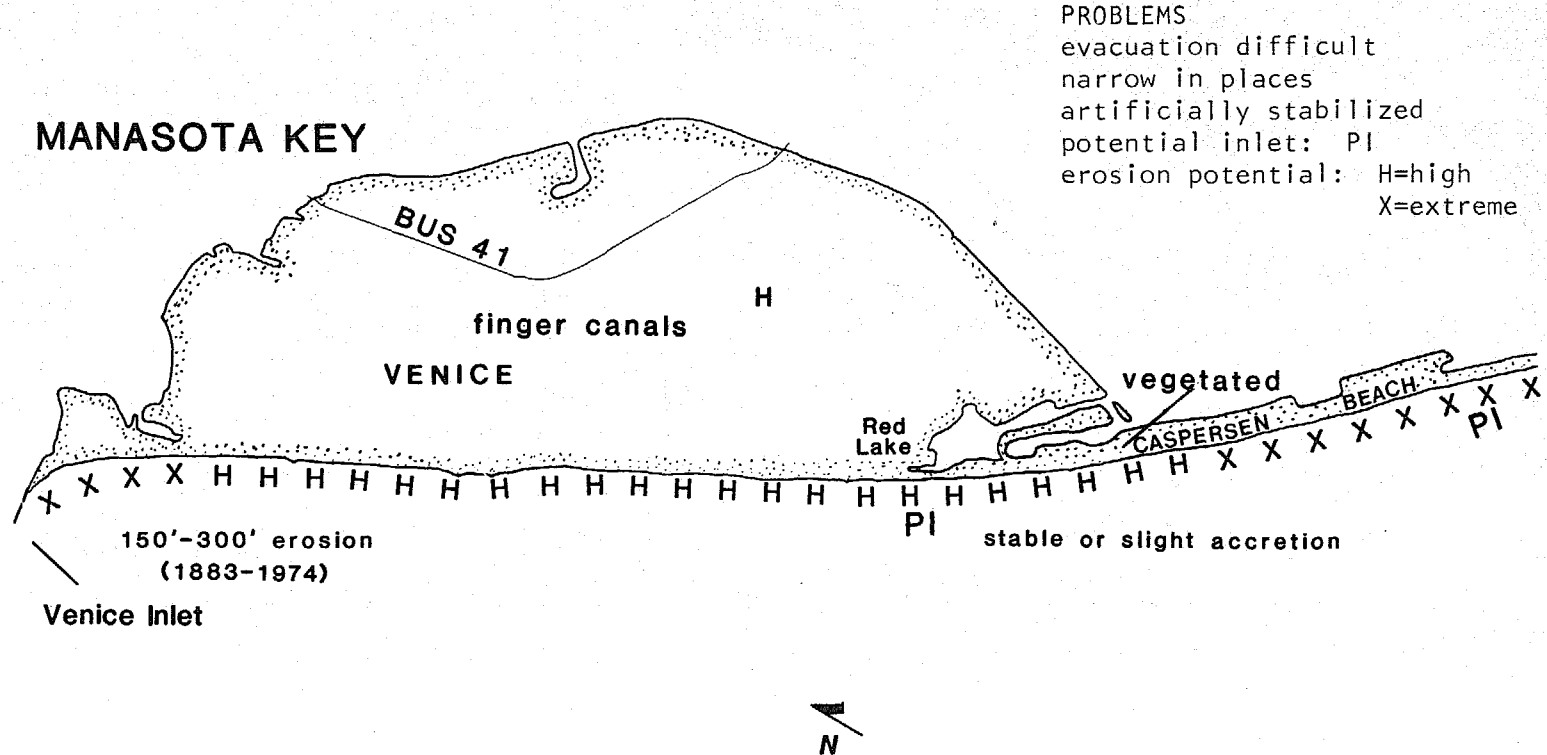
Fig. 5.39. Site analysis map: Casey Key and northern Manasota Key.

The beaches south of Venice Inlet are narrow and backed by low berms and some dunes south of Caspersen Beach (figs. 5.39 and 5.40). Manasota Key has some of the highest elevations on

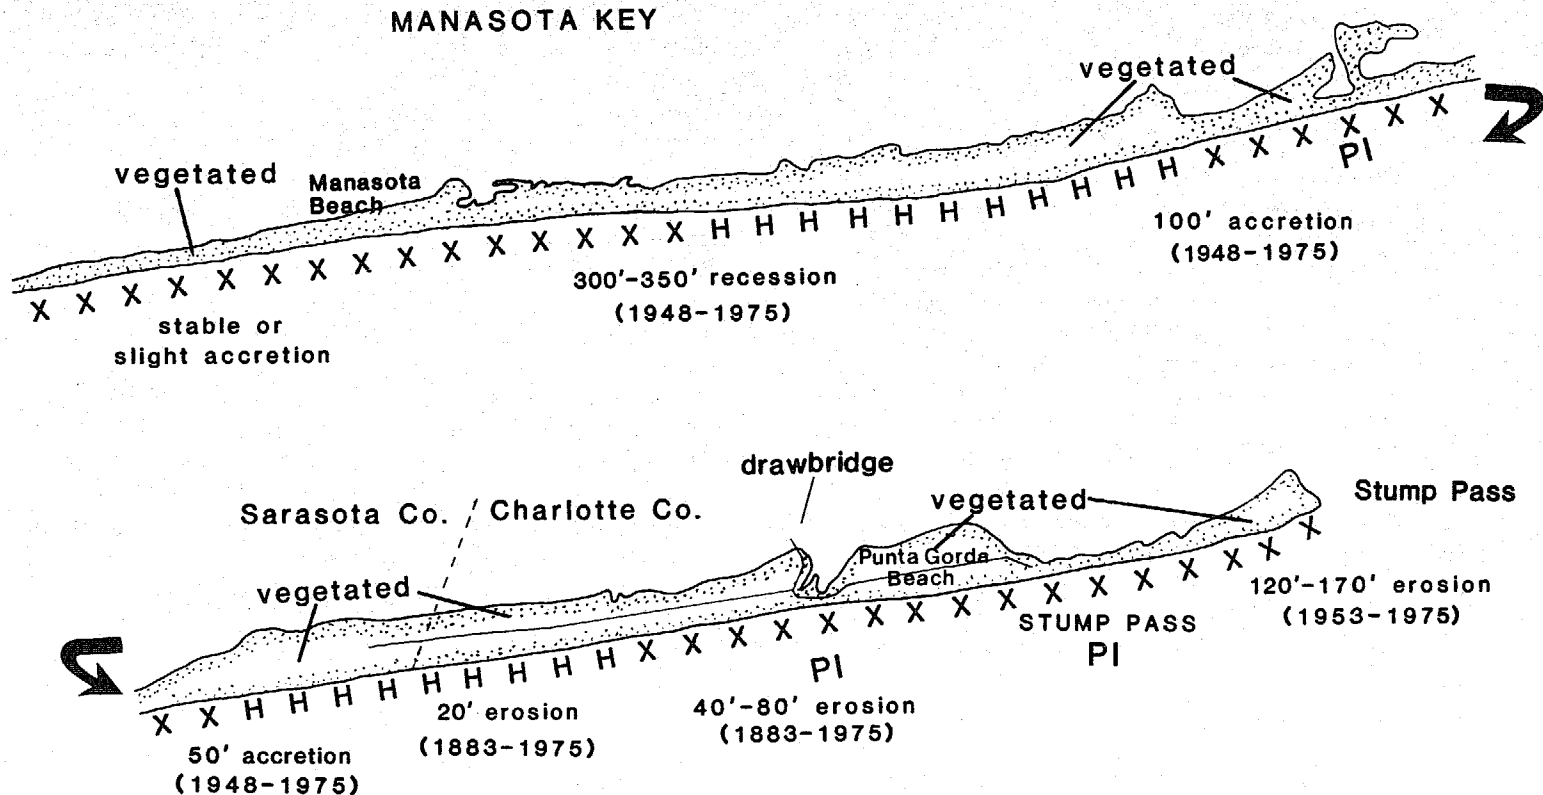
Fig. 5.40. Site analysis map: Manasota Key through Little Gasparilla Island.

Charlotte County has about 14 miles of barrier islands and spits. They are the southern 4 miles of Manasota Key, also known as Punta Gorda Beach and Englewood Beach (fig. 5.40); Knight–Don Petro–Little Gasparilla Island, 8 miles of barrier islands that were separated by Bocilla Pass, Blind Pass, and Little Gasparilla Pass in recent times (fig. 5.40); and the northern 2 miles of Gasparilla Island (fig. 5.41). These barrier islands range in width from 80 feet to 2,000 feet and have elevations ranging from 5 to 9 feet, with the average being slightly above 5 feet.

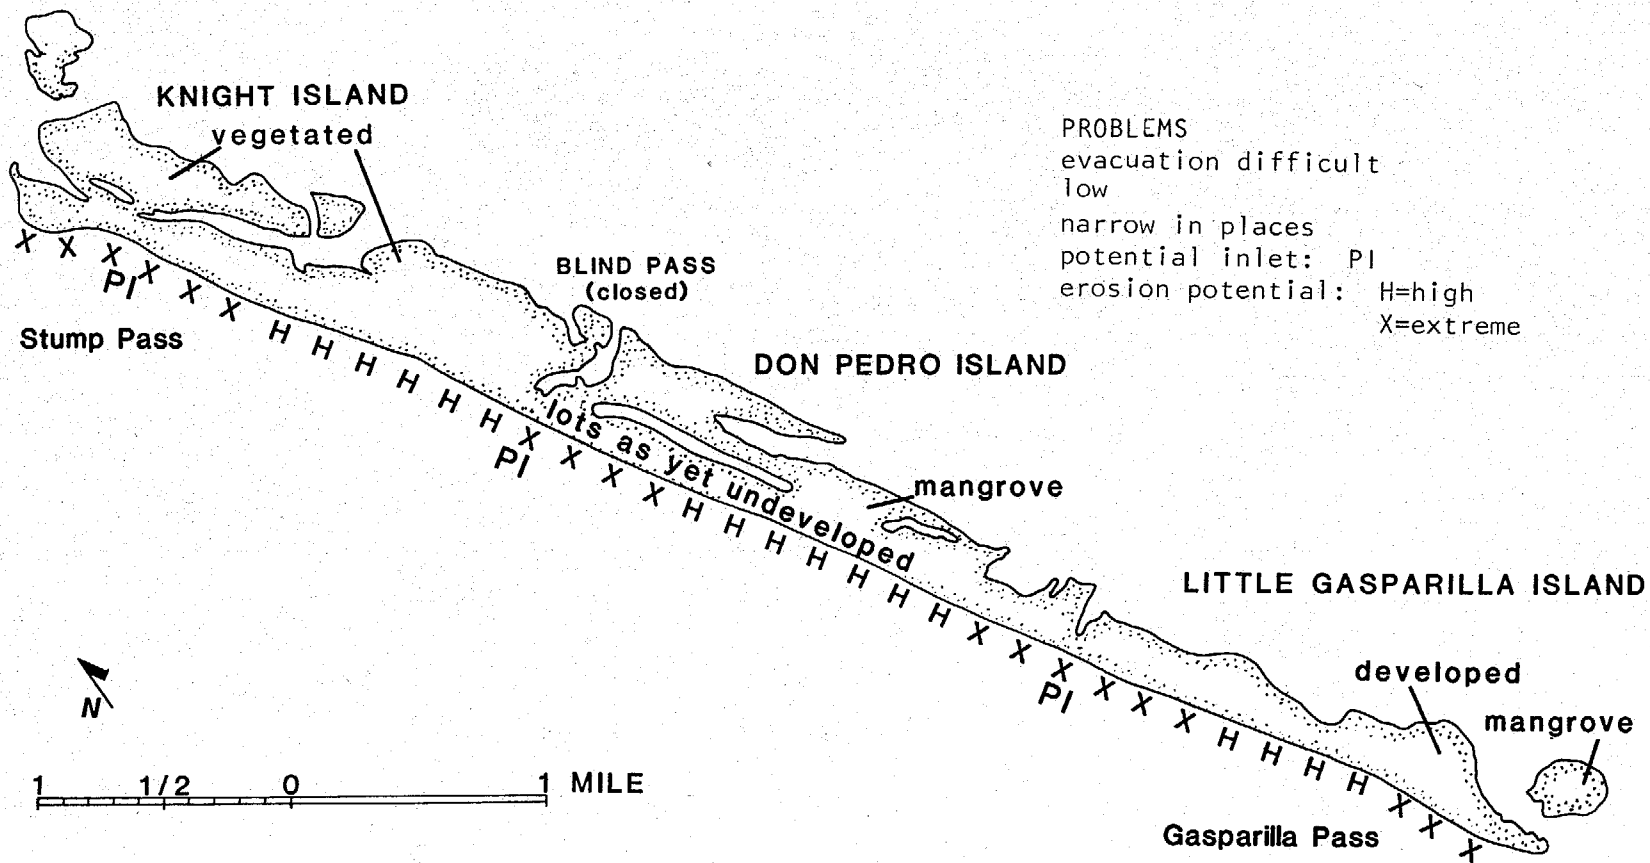
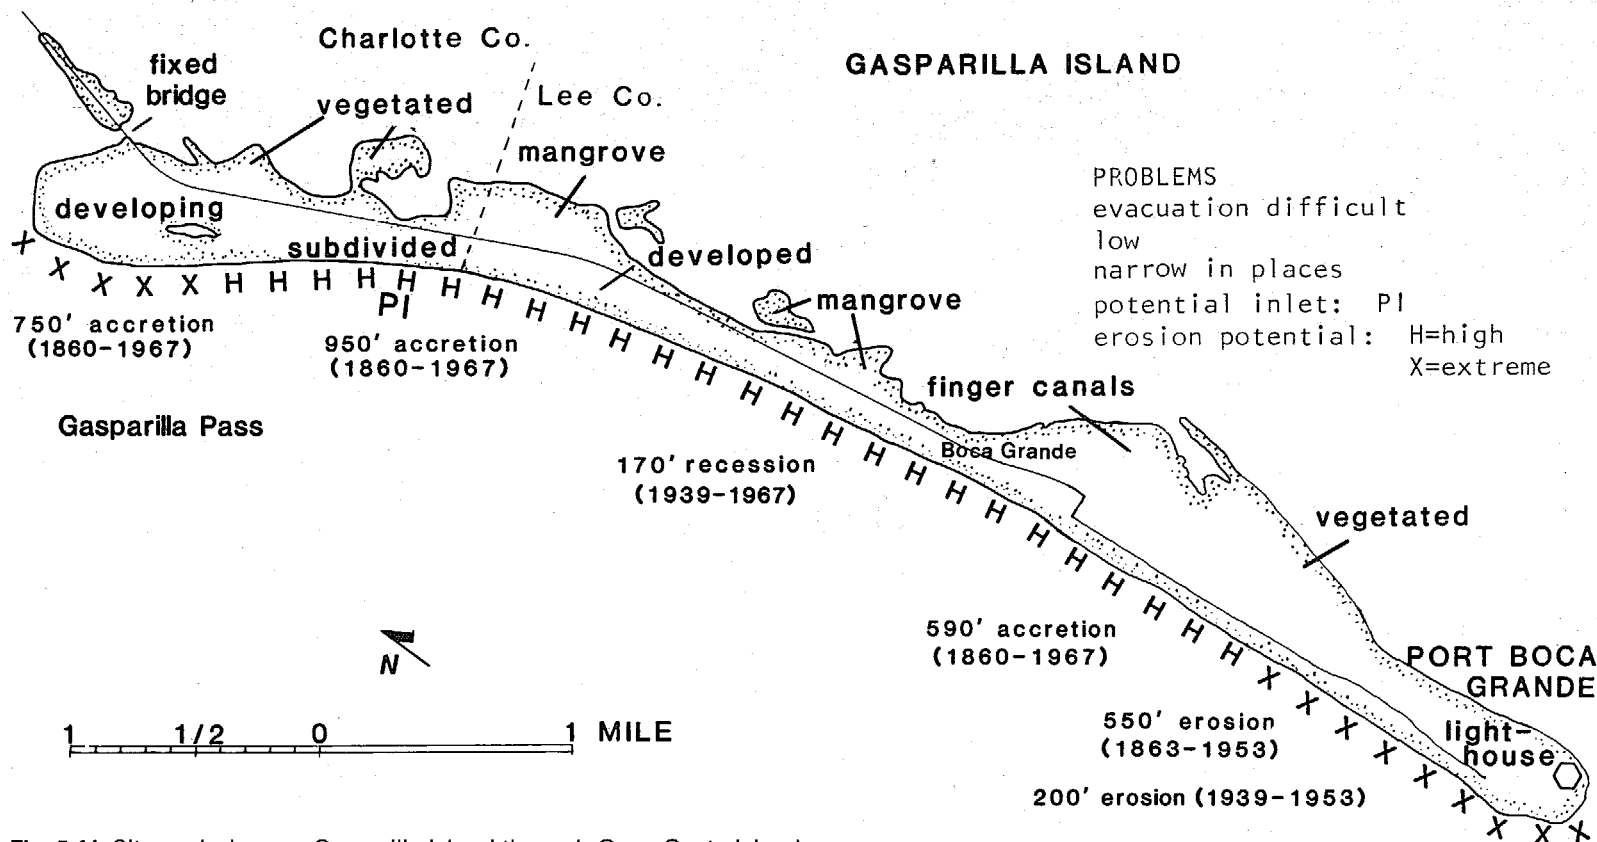
Fig. 5.41. Site analysis map: Gasparilla Island through Cayo Costa Island.

Gasparilla Island is a narrow island about 6.7 miles long, most of which is only between 5 to 7 feet above mean sea level (fig. 5.41). There is only 1 exit to the mainland at the northern end of the island. With the exception of a small area on the north end in Charlotte County, shoreline development is almost continuous. Old charts suggest that the island built out to the north about 750 feet in the last 100 years and that the southern end lost about 900 feet in the same period. The central section of the island has moved about 150 feet landward as well. Boca Grande Pass on the south is periodically dredged by the Corps of Engineers. At least 2 sheet-metal groins, 5 timber groins, 13 permeable concrete groins, 22 stone groins, and 9,600 feet of seawall have already been constructed on Gasparilla Island. About 70 feet of seawall on the southern end, part of a 700-foot section constructed by the county to protect the road, failed during Hurricane Gladys in October 1968. It was rebuilt in the same location.

Cayo Costa (or Lacosta; fig. 5.41) Island and North Captiva

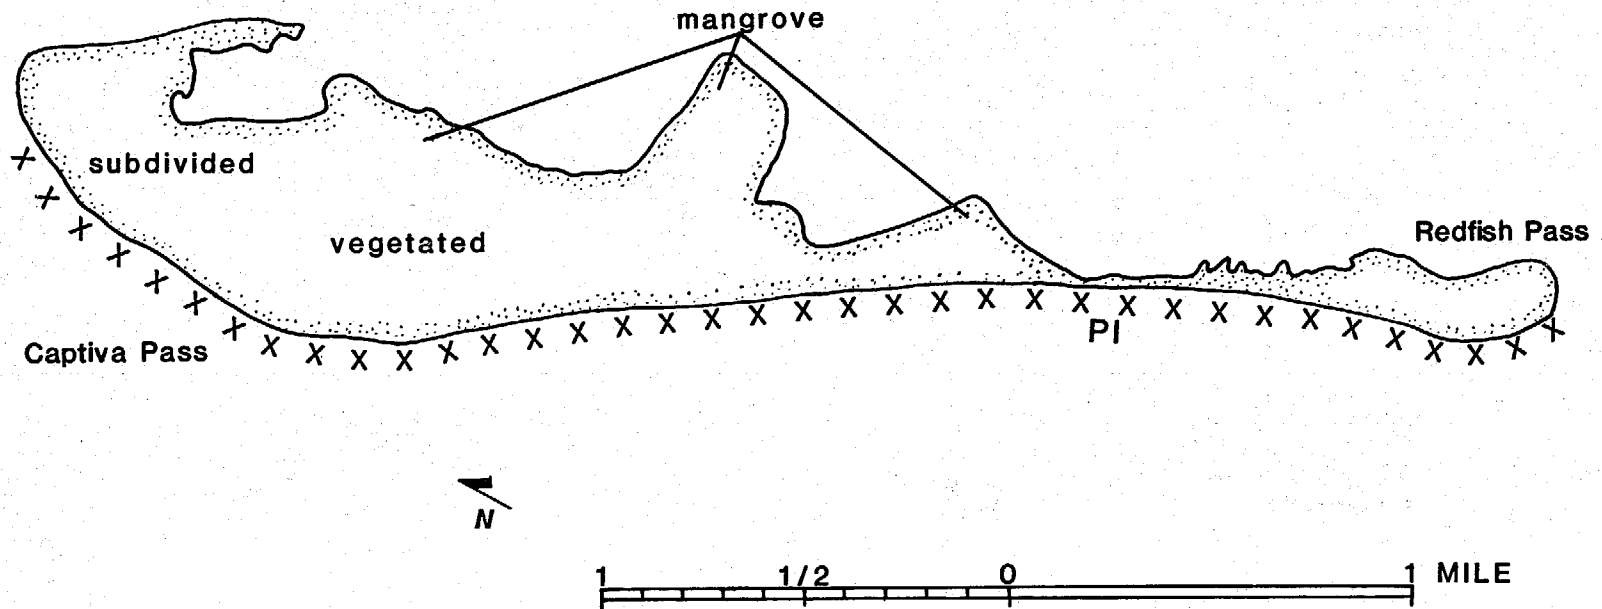
Fig. 5.42. Site analysis map: North Captiva Island.

Island (fig. 5.42) are 7.3 and 4.3 miles long, respectively. Cayo Costa varies in width from about 300 feet at the narrows near the south end to 6,400 feet at its widest point just north of the middle of the island. The width of North Captiva varies from about 200 feet near the south end to about 3,200 feet near the middle. In general, these 2 islands have elevations of only 5 to 6 feet above mean sea level. Cayo Costa has about 10 structures, while North Captiva Island has over 40 existing structures and is undergoing slow development. Neither island is attached to the mainland. The northern end of the island near Boca Grande Pass and the southern end near Captiva Pass show steep scarps, indicating migration. The southern end of Cayo Costa is separated from the wider section by an old pass that has been closed off. Both islands are in a relatively natural state compared with their neighbors, and study of old charts shows that they are undergoing normal migration. Captiva Pass and Redfish Pass at the south end of North Captiva Island have not been dredged to this time. Captiva Island is about 5 miles long and varies somewhat from less than 200 feet wide at the south end to about 2,000 feet wide near the center (fig. 5.43). The narrow southern strip of sand represents the recent natural closure of Blind Pass, which used to separate Captiva Island from Sanibel Island. Most of the Gulf side is developed as residential and resort areas. The island is engineered with seawalls, groins, and beach renourishment and is experiencing serious ongoing erosion problems (fig. 5.44).

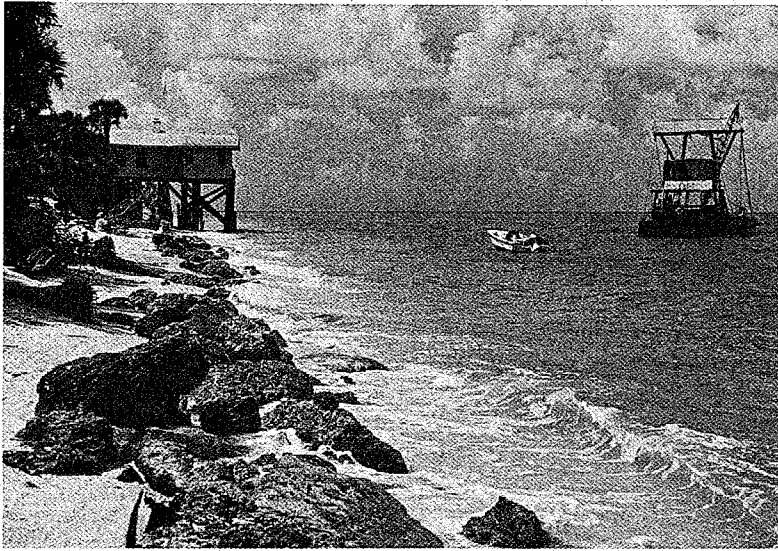
Fig. 5.44. Erosion at the north end of Captiva Island. The rocks placed here will, at best, only temporarily slow down erosion. Photo by Dinesh Sharma.

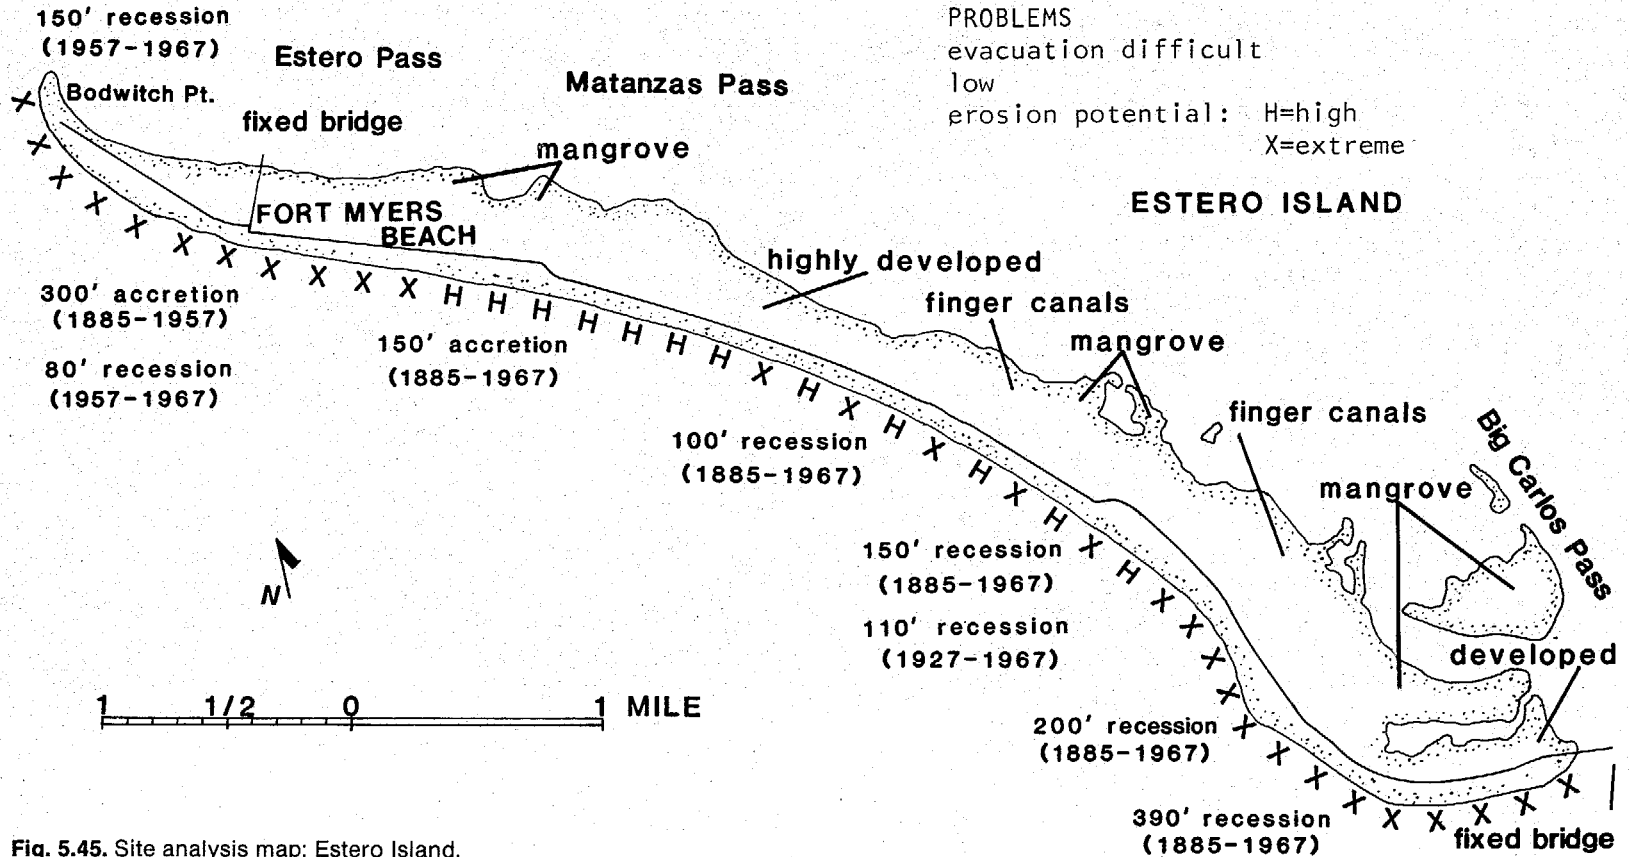
Fig. 5.45. Site analysis map: Estero Island.

Estero Island is also known as Fort Myers Beach (fig. 5.45). The Gulf shoreline is about 7 miles long, and the island width varies from 400 to 3,800 feet. The elevations are generally below 7 feet. In several locations along the island artificial canals from the bay side have been dug toward the beach, making the island vulnerable to breaching during hurricanes and tropical storms. Much of the Gulf front has been intensively urbanized for commercial, resort, and residential uses. Only the northern few acres at Bodwitch Point remain undeveloped. A new, ephemeral sand bar, locally called Little Estero Island, has been emerging along the southern 2.5 miles of the island. This sand bar is highly dynamic, unstable, and low in elevation. However, its presence provides some protection to the naturally eroding beaches on the southern end of Estero Island. Estero Island's Gulf shoreline is armored with 87 stone groins, 4 timber groins, 2 combination stone-timber groins, and more than 6,000 feet of linear concrete seawalls and some rock revetments. Additional seawalls, bulkheads, and revetments have been placed on the back bays of the island coastline. During the Matanzas Pass channel maintenance dredging in 1980, about 130,000 cubic yards of sand were placed along the northern 1.0 mile of Estero Island beach. The north end of Estero Island retreated 80 to 150 feet between 1957 and 1969 and up to about 400 feet on the southern end over the past 100 years.

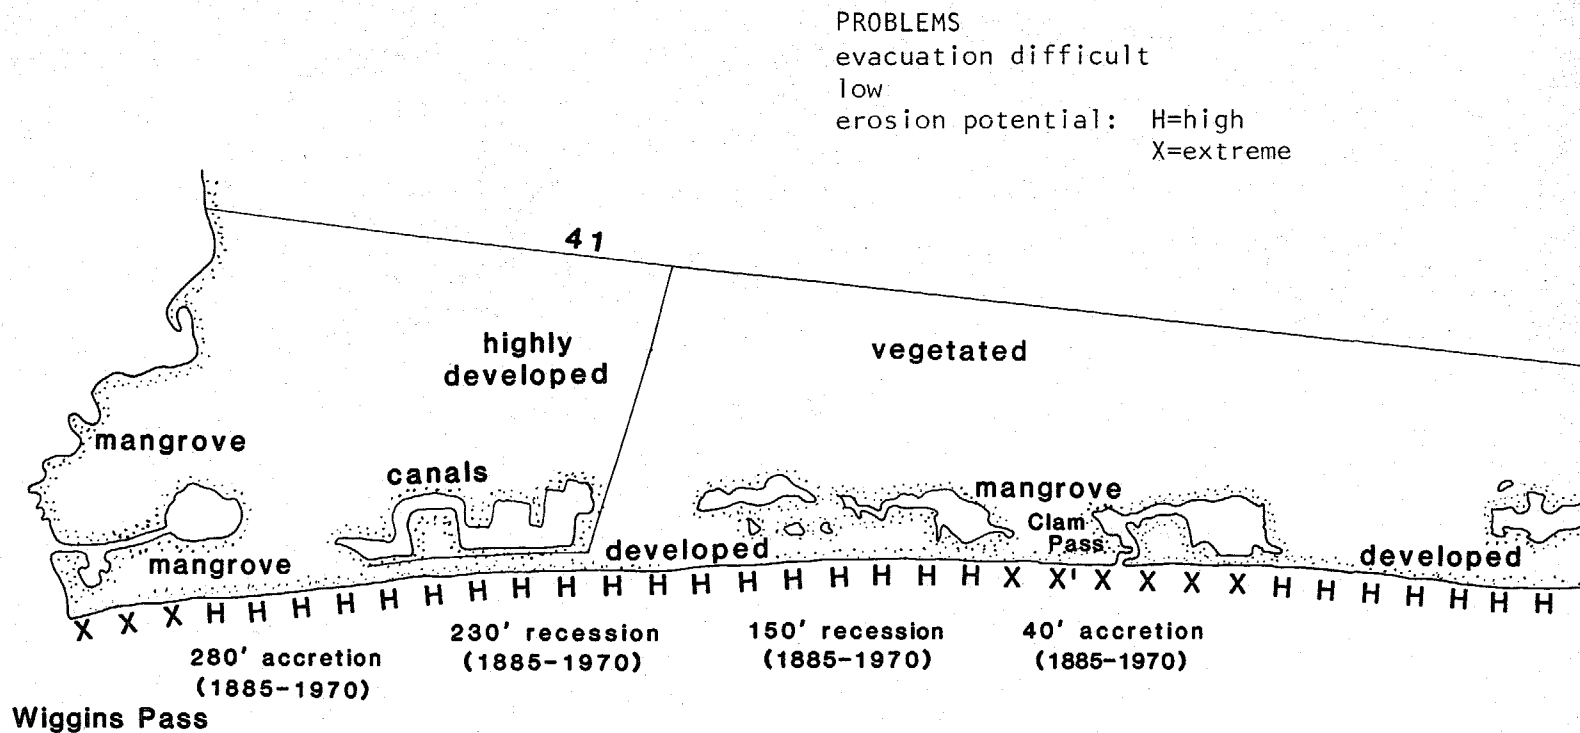
Fig. 5.47. Site analysis map: Mainland coast through Gordon Pass.

Naples City Beach is 5.6 miles long, bounded on the north by Doctors Pass and on the south by Gordon Pass (fig. 5.47), and has been stabilized with timber-stone terminal groins to provide a navigation channel 12 feet deep and 150 feet wide. The Gulf beach is generally low and only 20 to 50 feet wide. Extensive dredge-and-fill finger canal development on the south end near Naples Bay make this area vulnerable to breaching during storms.

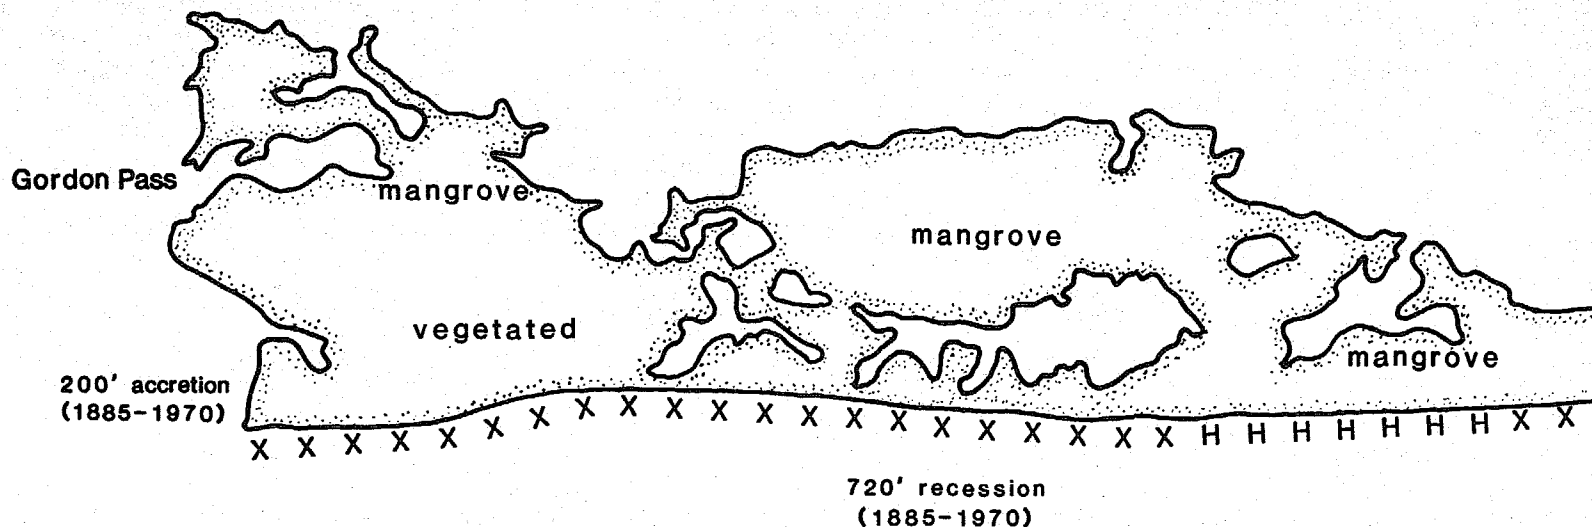
Fig. 5.48. Site analysis map: Keewaydin Island.

The Keewaydin Island group is about 9.3 miles long and 2,980 acres in area (fig. 5.48). There are 2,230 acres of wetland and 750 acres of upland in the unit. The island is bounded on the south by Little Marco Pass. Elevations are generally 3 to 6 feet along the beach and dip toward the back bay. The width varies from about 4,000 feet in the north to 200 feet in the south. The beaches are generally narrow and steep with erosional scarps in several places.

Keewaydin Island has a history of advance and retreat and has several historic inlets, potential inlets, and overwash areas. From 1885 to 1970 the shoreline advanced an average of 150 feet, with the greatest advance being south of Gordon Pass (200 feet) and north of Little Marco Pass (570 feet). Since 1970 the southern end of the island has built out several thousand feet in the southerly

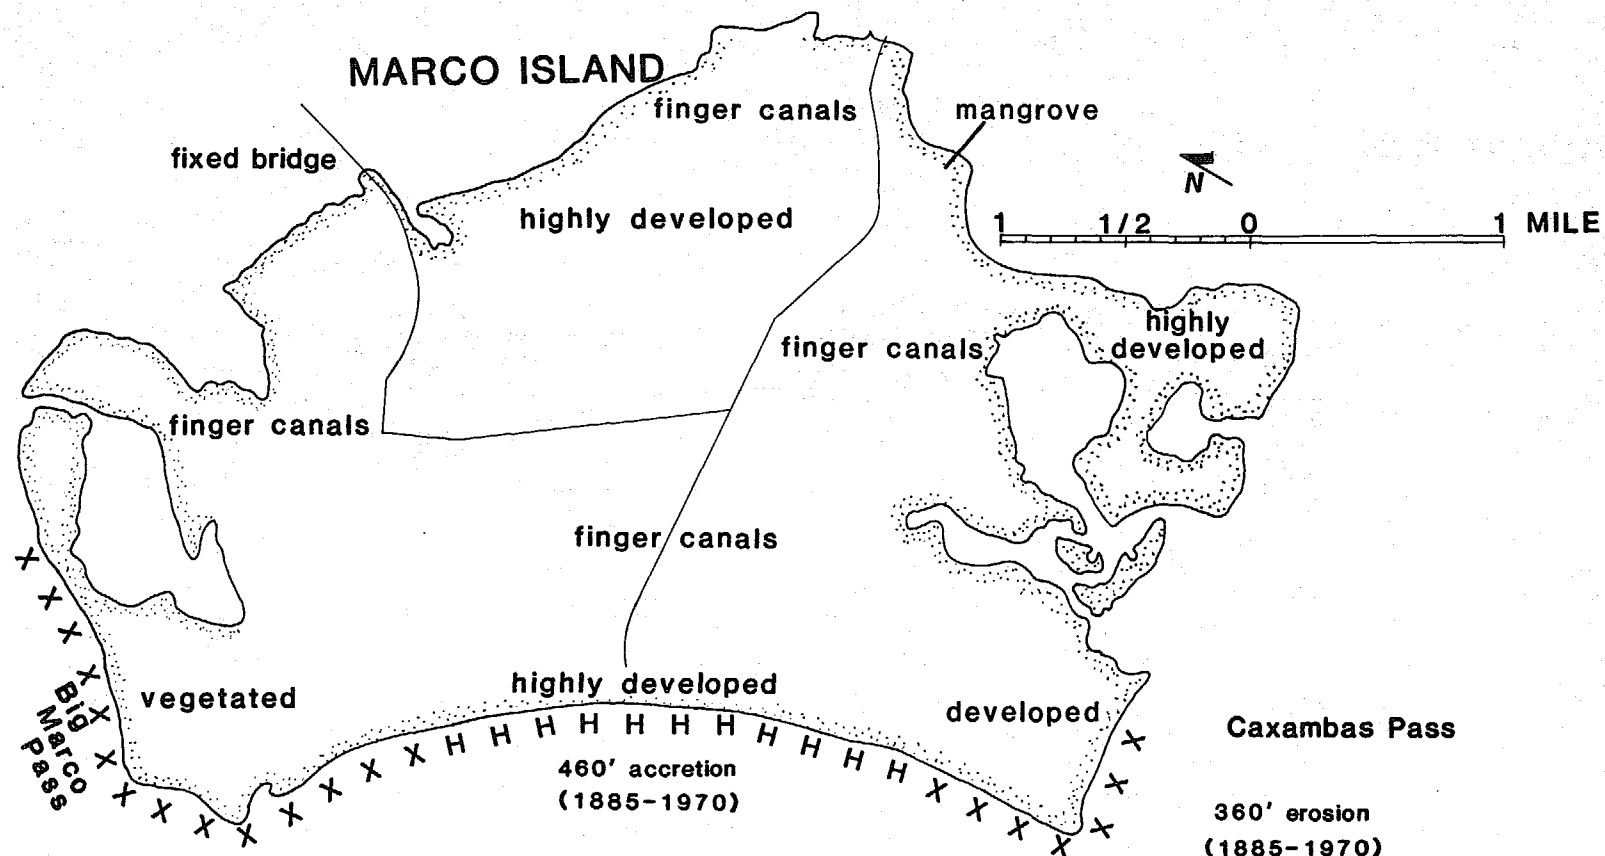
Fig. 5.49. Site analysis map: Marco Island.

low
narrow in places
potential inlet: Pl
erosion potential: H=high
X=extreme

Marco Island is about 4.6 miles long and 5,100 acres in size (fig. 5.49). Approximately 785 acres of wetlands remain on the island after extensive dredging and filling in the 1970s. Much of the island is 4 to 7 feet in elevation, with 1 small area north of the Marriott Hotel exceeding 10 feet. Marco Island has beaches from 100 to 150 feet in width. The northern 0.5 mile of beach front is owned by Collier County.

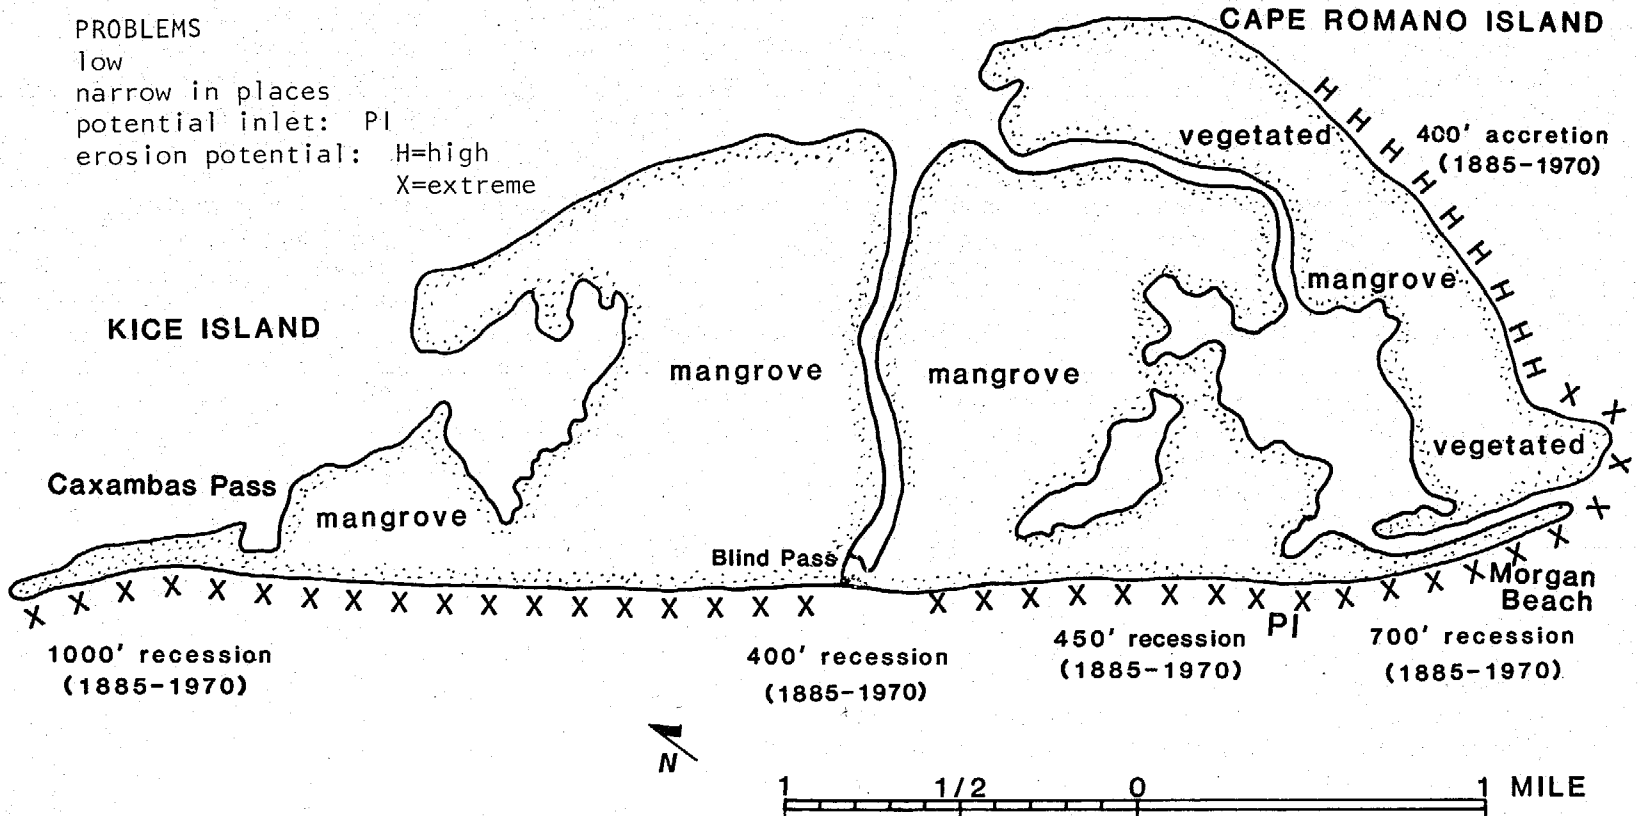
Fig. 5.50. Site analysis map: Kice Island and Cape Romano Island.

Kice Island, Morgan Beach, and Cape Romano appear to be a unified barrier island group (fig. 5.50). These islands have about 4.8 miles of sandy beach with a total area of about 2,650 acres (much of which is wetlands) behind the narrow beach berm. There are 3 passes, Caxambas Pass in the north, Blind Pass in the middle (now closed), and Morgan Pass in the south. The Cape Romano

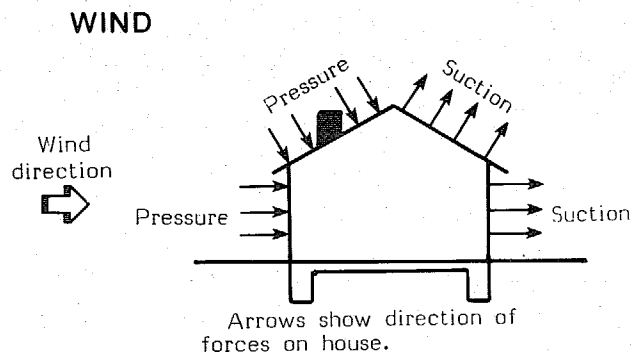
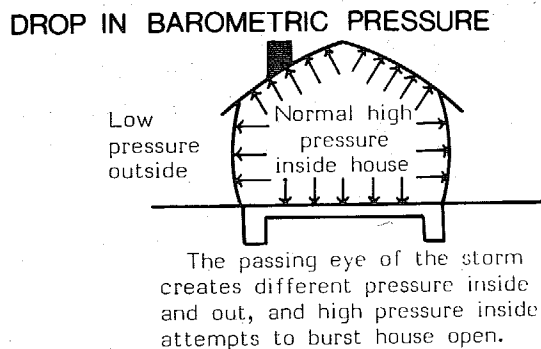
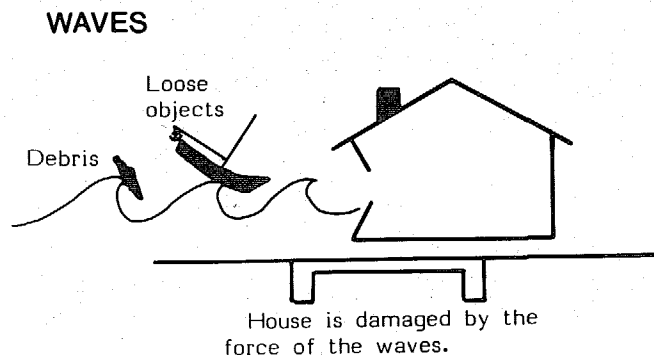
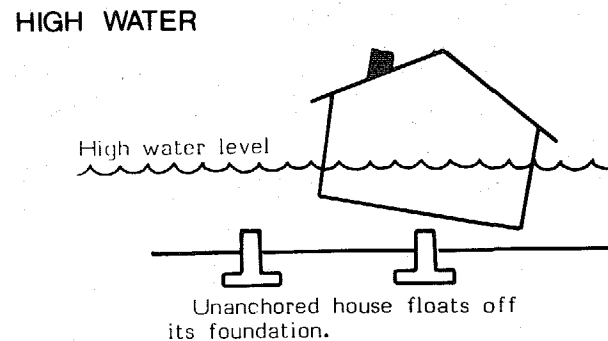
Fig. 6.1. Forces to be reckoned with at the shoreline.

Hurricanes, with their associated high winds and storm surge topped by large waves are the most destructive of the forces to be reckoned with on the coast. Figure 6.1 illustrates the effects of hurricane forces on houses and other structures.

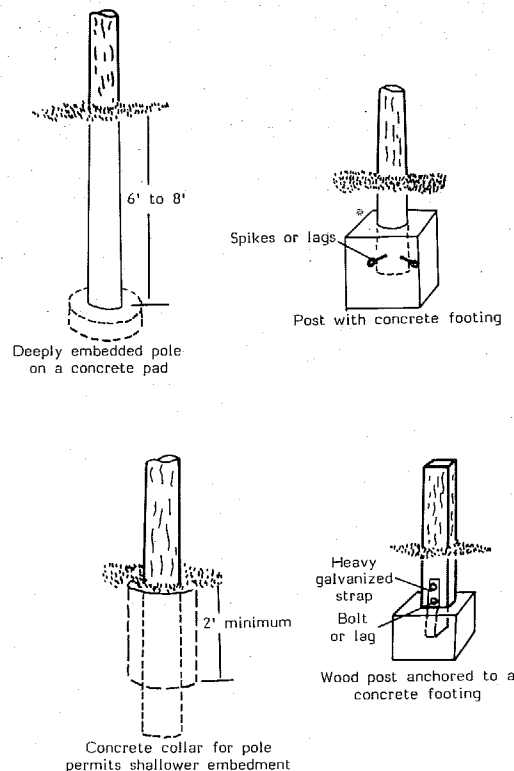
Fig. 6.3. Shallow and deep supports for poles and posts. Source: Southern Pine Association.

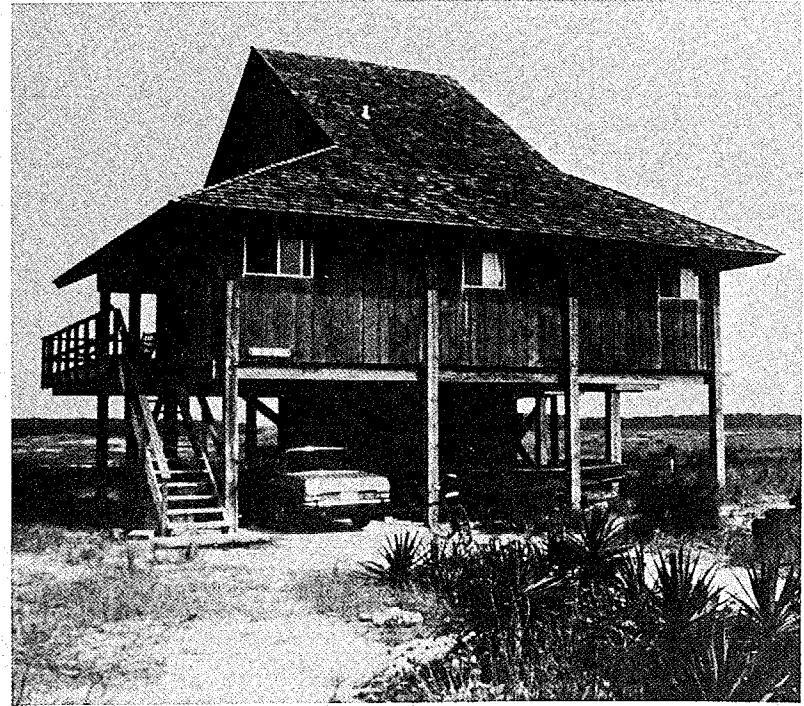
Fig. 6.4. Pole house, with poles extending to the roof. Extending poles to the roof, as shown in this photograph, instead of the usual method of cutting them off at the first floor, greatly strengthens a beach cottage. Photo by Orrin Pilkey, Jr.

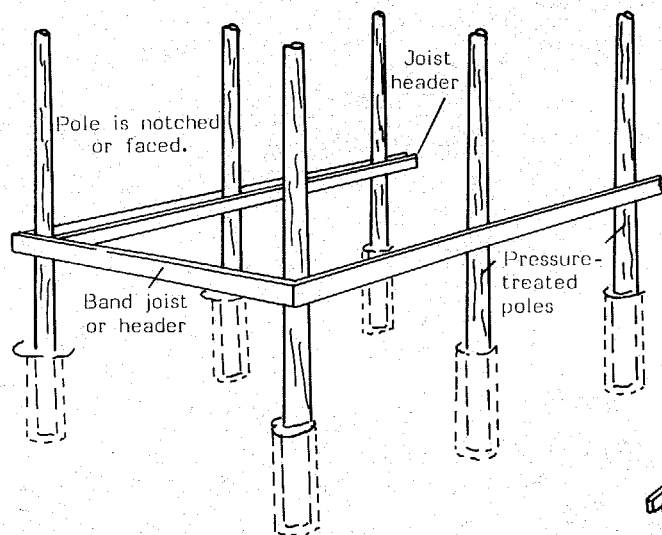
Depth of embedment may vary from 6 to 10 feet, depending on spacing and size of poles, wind load, and so forth.

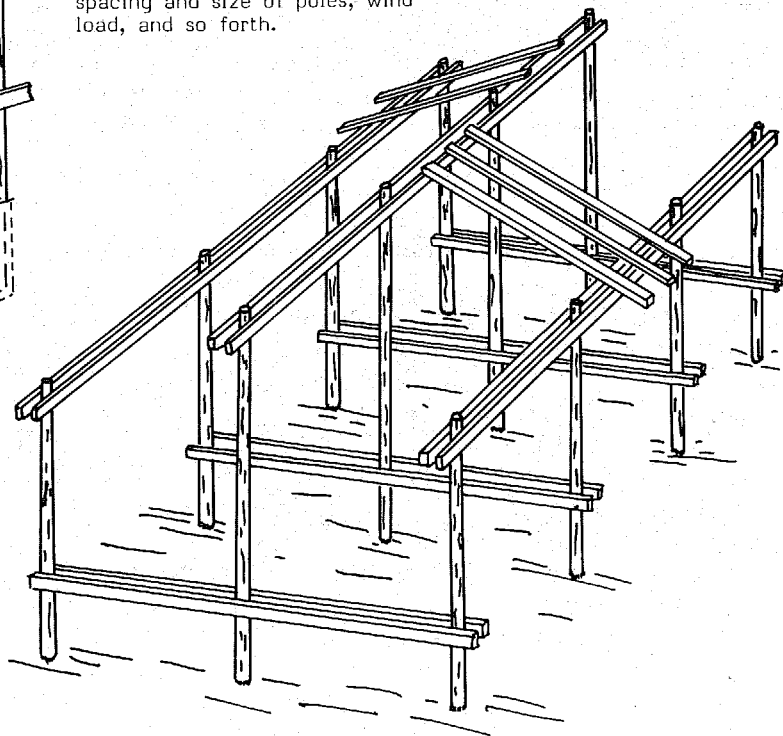
Fig. 6.5. Framing system for an elevated house. Source: Southern Pine Association.

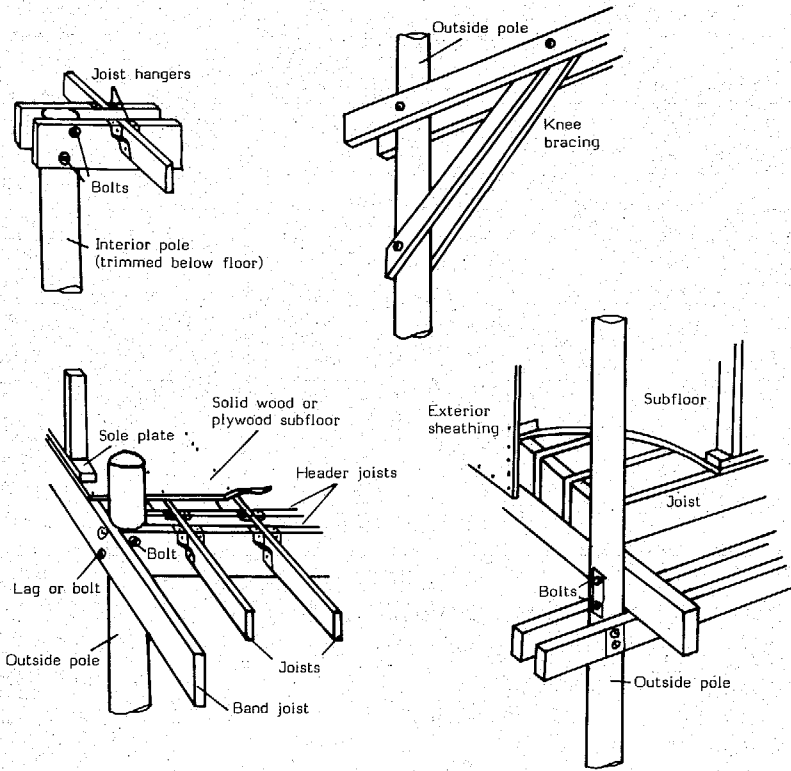
Fig. 6.6. Tying floors to poles. Source: Southern Pine Association.

Pole construction can be of two types. The poles can be cut off at the first-floor level to support the platform that serves as the dwelling floor. In this case, piles, posts, or piers can be used. Or they can be extended to the roof and rigidly tied into both the floor and the roof. In this way they become major framing members for the structure and provide better anchorage to the house as a whole (figs. 6.4 and 6.5). A combination of full- and floor-height poles is used in some cases, with the shorter poles restricted to supporting the floor inside the house (fig. 6.6).

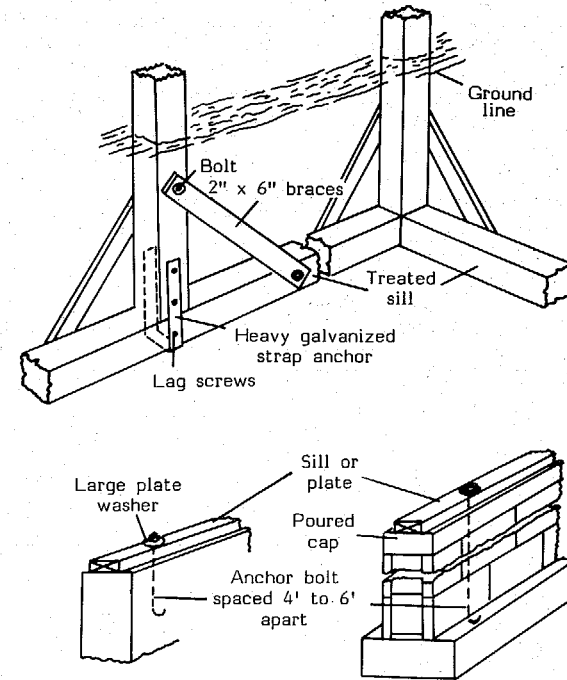
Fig. 6.7. Foundation anchorage. Top: anchored sill for shallow embedment. Bottom: anchoring sill or plate to foundation. Source of bottom drawing: *Houses Can Resist Hurricanes*, U.S. Forest Service Research Paper FPL 33.

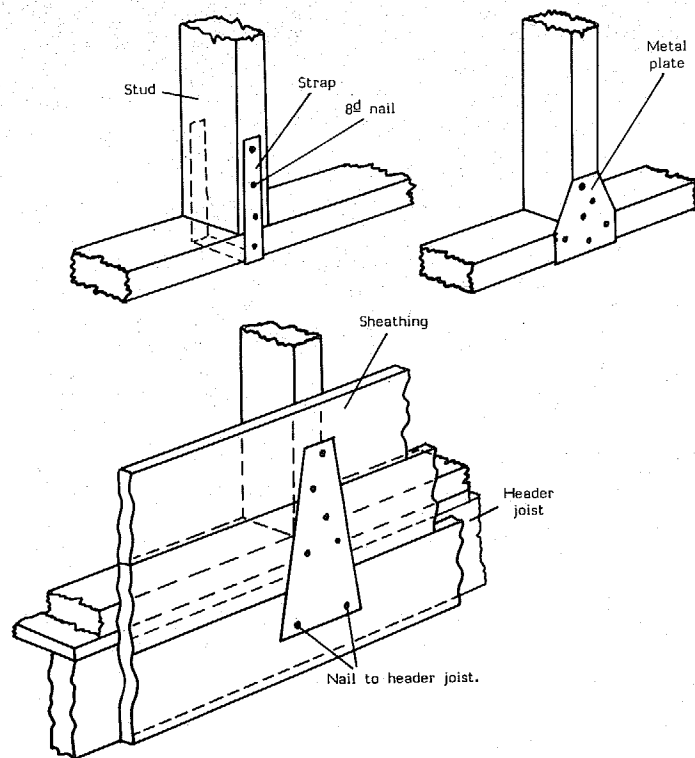
Fig. 6.8. Stud-to-floor, plate-to-floor framing methods. Source: *Houses Can Resist Hurricanes*, U.S. Forest Service Research Paper FPL 33.

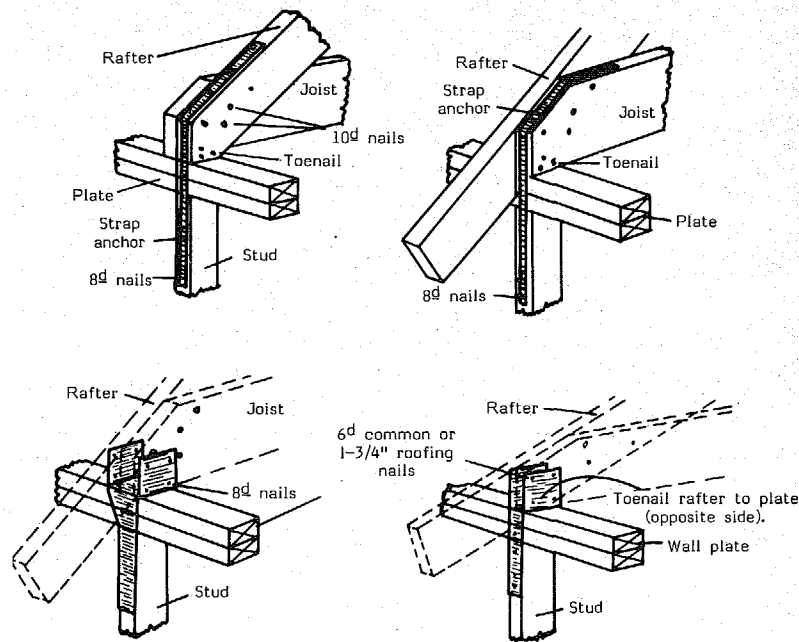
Fig. 6.9. Roof-to-wall connectors. The top drawings show metal strap connectors: left, rafter to stud; right, joist to stud. The bottom left drawing shows a double-member metal plate connector—in this case with the joist to the right of the rafter. The bottom right drawing shows a single-member metal plate connector. Source: *Houses Can Resist Hurricanes*, U.S. Forest Service Research Paper FPL 33.

The roof should be well anchored to the walls. This will prevent uplifting and separation from the walls. Visit the attic to see if such anchoring exists. Simple toe-nailing (nailing at an angle) is not adequate; metal fasteners are needed. Depending on the type of construction and the amount of insulation laid on the floor of the attic, these may or may not be easy to see. If roof trusses or braced rafters were used, it should be easy to see whether the various members, such as the diagonals, are well fastened together. Again, simple toe-nailing will not suffice. Some builders, unfortunately, nail parts of a roof truss just enough to hold it together to get it in place. A collar beam or gusset at the peak of the roof (fig. 6.10) provides some assurance of good construction. The Standard Building Code states that wood truss rafters shall be securely fastened to the exterior walls with approved hurricane anchors or clips.

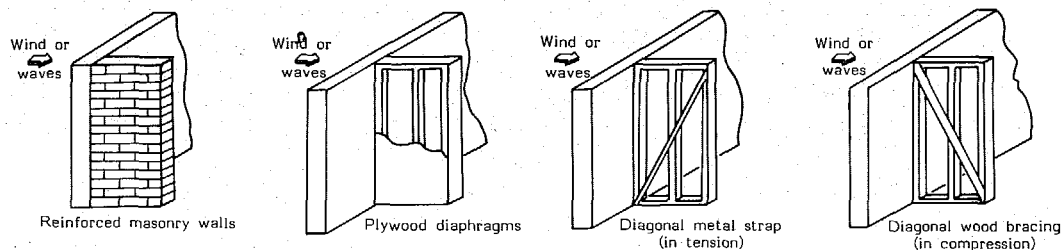
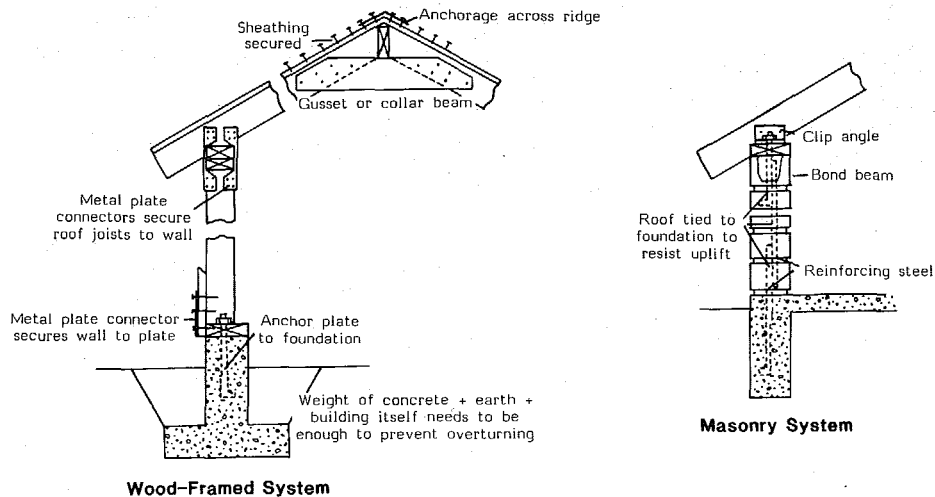
Reinforce exterior walls by bracing perpendicular interior walls

Fig. 6.10. Where to strengthen a house. Modified from U.S. Civil Defense Preparedness Agency Publication TR-83.

When accessible, roof rafters and trusses should be anchored to the wall system. Usually the roof trusses or braced rafters are sufficiently exposed to make it possible to strengthen joints (where 2 or more members meet) with collar beams or gussets, particularly at the peak of the roof (fig. 6.10).

reinforcement against the wind. These straps are commercially produced and are made of 16-gauge galvanized metal with pre-punched holes for nailing. These should be secured to studs and wall plates as nail holes permit (fig. 6.10). Bear in mind that they are good only for tension.
